How to fix touch buttons on Sony SRS-X7

Touch buttons become non-functional, rendering speaker almost-useless.

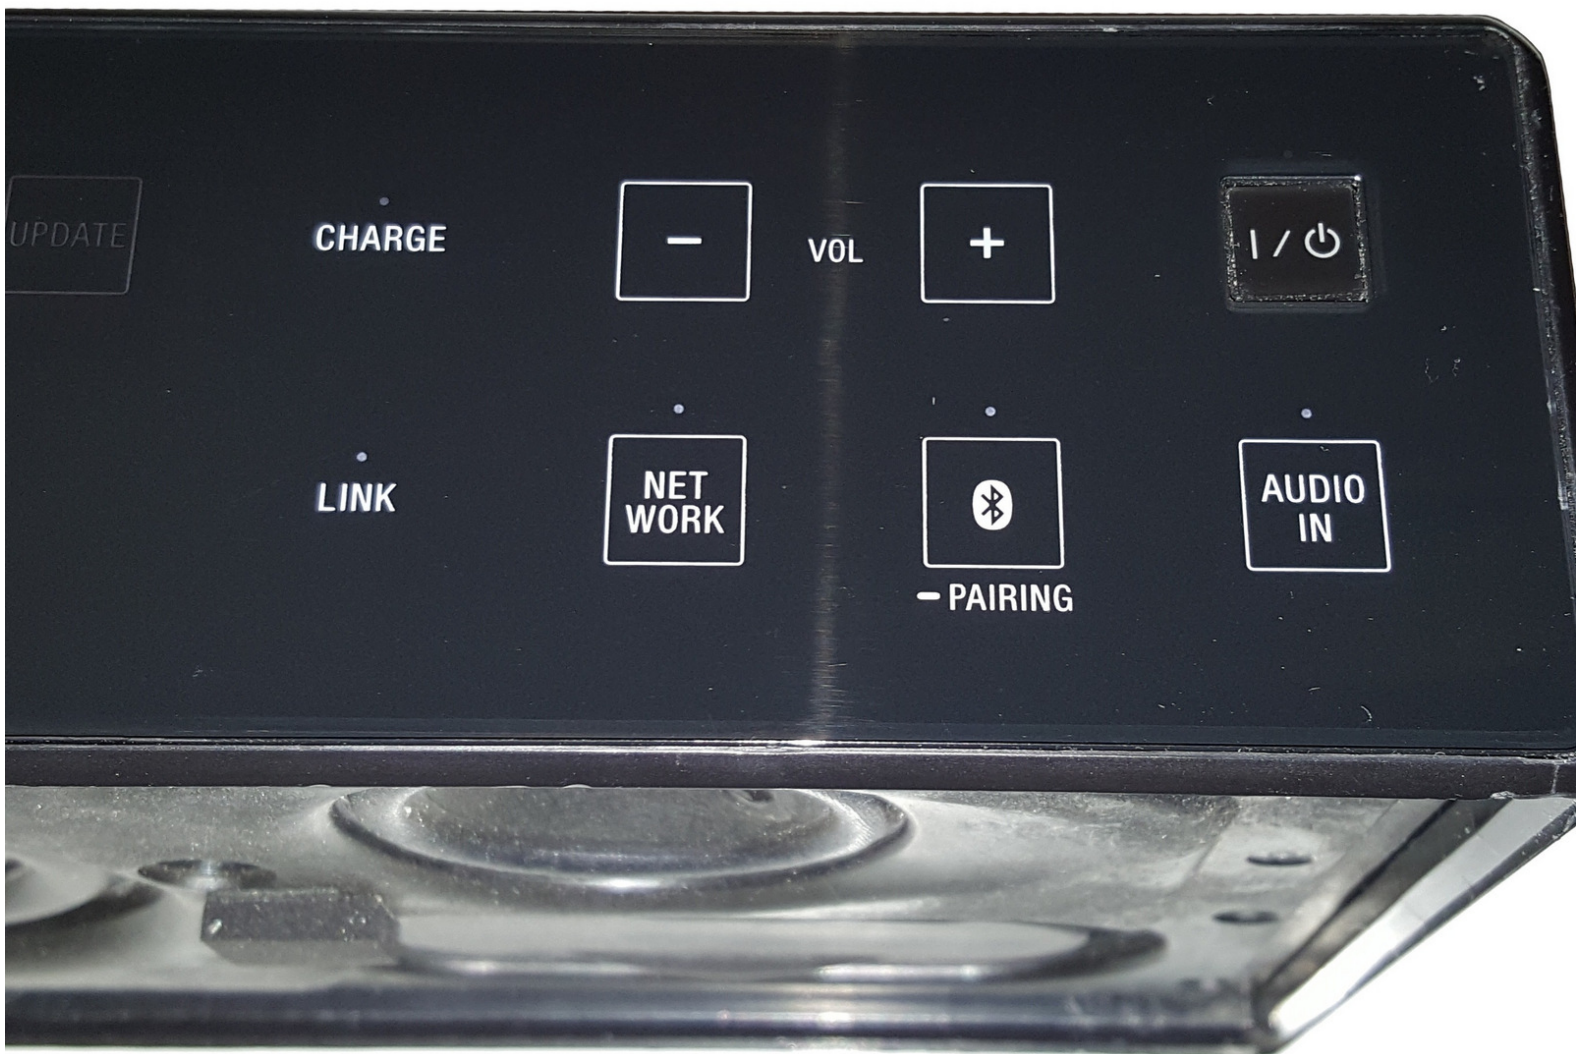
Over time, the touch buttons on the SRS-X7 may stop functioning. Double-sided tape used during manufacturing is the cause of the problem - probably as a result of degradation of the glue causing a change in capacitance.

Rather than paying a Sony service department to look at your speaker, repair it yourself economically.
